PROCEEDINGS OF THE INTERNATIONAL SYMPOSIUM ON GEOTECHNICAL
ENGINEERING FOR THE PRESERVATION OF MONUMENTS AND HISTORIC SITES
NAPOLI/ITALY/3-4 OCTOBER 1996

St-John's Church, Tartu, Estonia – Underpinning of tower

K. Avellan
KAREG Consulting Engineers, Helsinki, Finland

K. Lange
AS Stinger, Tartu, Estonia

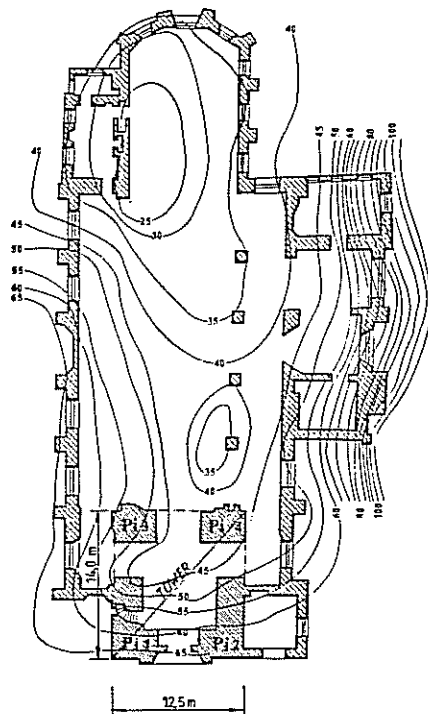
During recent decades, the tower began to sink because of the lowering of the groundwater table.

Fig. 2. Settlement lines.

In the last few years the water level has dropped below the wooden rafts. As a result, the wood has begun to rot, thus accelerating the sinking process. For this reason, the work began with the restoration of the tower foundations. The settlement lines are shown in FIG. 2.

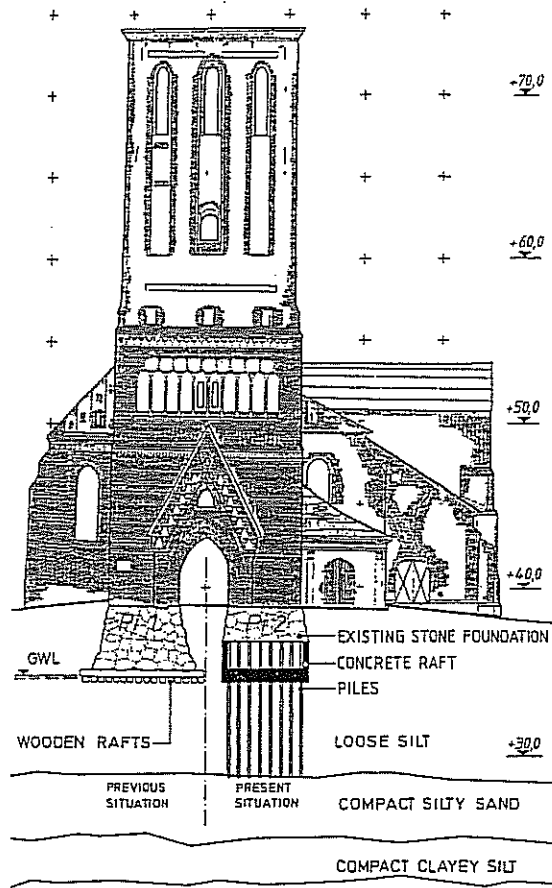
Fig. 3. Western elevation with underpinning of tower.

The foundation work was completed for each leg by joining it to a reinforced-concrete raft foundation, thus creating a partly "floating piled raft". This raft was realized casting section by section and providing bond connections with individual piles. One reason for making the rafts part by part for each leg, was to avoid dangerous cavity situations. The floating piled raft and the tower are shown in FIG. 3.

To minimise the use of steel reinforcement, the slabs were in fact designed as a series of inverted arches. As such, a minimum of steel was necessary to join the slab effectively to the piles.

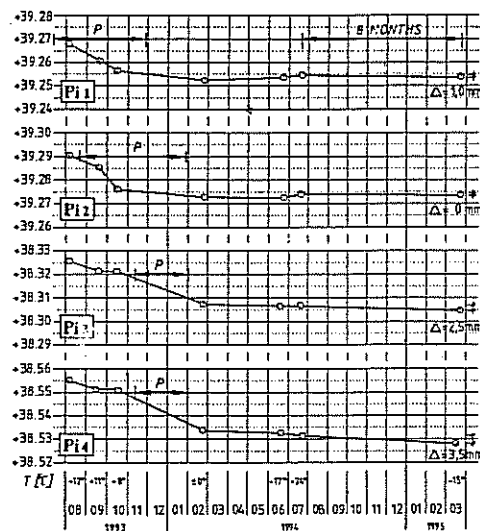
Fig. 4. Piling time (P) and observed settlements.

During the work period, the movements of the tower as well as the rate of settling were registered. The settling was verified at 4 points, and measured from 18mm to 20mm. (FIG. 4)

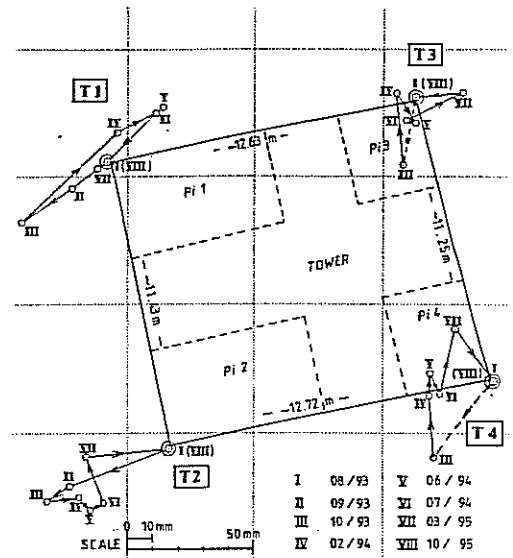
NOTE: THE POINTS AT VIII ARE CLOSE TO THE ORIGINAL POSITION I

Fig. 5. Horizontal displacements of the top of the tower.

During the course of the work, the tower moved from side to side to a maximum of 30mm to 50mm from the original position. This movement coincided with the work that was done in the different parts of its base. (FIG. 5)

The tower has stabilized at 5mm to 10mm from the initial reference point. This represents an inclination of 1:7600...1:3800, that can only be seen with special equipment.
