ECSMGE XV European Conference on Soil Mechanics & Geotechnical Engineering, 12.. – 15. September 2011, Athens, Greece

Drilled spiral piles in St. John's Church of Tartu, Estonia

K. Avellan

KAREG Consulting Engineers Ltd, Helsinki, Finland

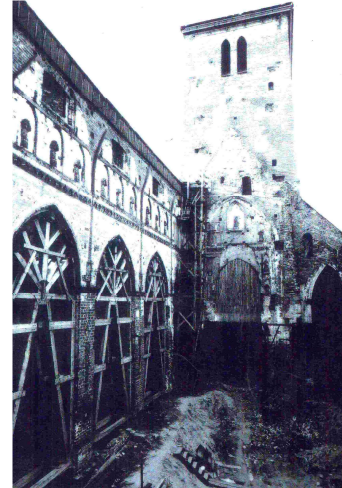
Figure 2. St. John's Church before the strengthening work. Line A is on the right-side without roof, columns on line B had to be entirely rebuilt (see Fig. 3).

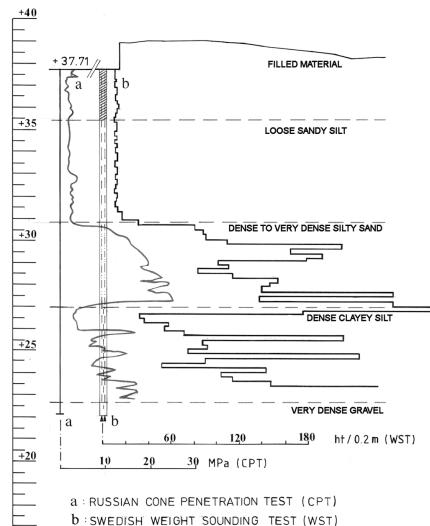
The existing foundations of the church are on massive stones, which themselves sit on wooden rafts. The height of the stone setting is about 3 m. On the lowest parts of the building, situated in the south-western and south-eastern corners, the stone setting is 1.5-2 m high. On the top layer these stones are joined together with mortar, but at the lower level the joints are filled with sand. The double wooden raft under the stone setting was made from Ø 30 - 40 cm wood trunks. The ground under the church consists of a variety of different soil layers. The approximate thicknesses of the soil layers under the wooden rafts are shown in Fig. 3.

The consolidation process of the loose sandy silt layer has ended because of its thickness (5 m) and time-lapse (more than five hundred years). The outside earth surface of the church has risen in the past because of the addition of “cultural layers”. During recent industrialisation decades the building began to sink because of the lowering of the ground water table. In the last few years before the strengthening work was started the water level had dropped below the level of the wooden rafts.

Figure 3. Russian cone penetration test (CPT) and Swedish weight sounding test (WST). Soil exploration results at sample point near the church wall.

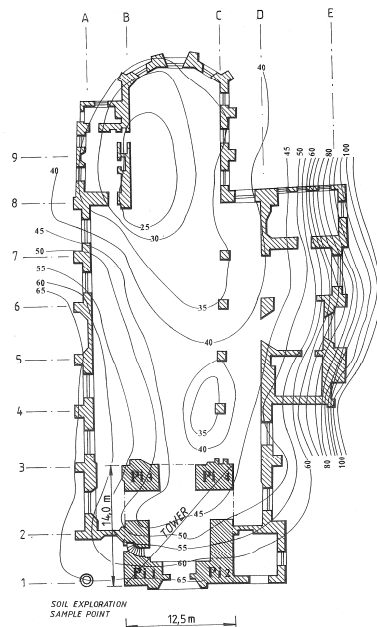
Figure 4. Contour lines of settlement (mm) in the area of the church during the years 1963-87 [2]. Line A is on the left-side without roof, columns on the line B, where the burial chamber is located, had to be rebuilt.

As the result, the wooden rafts had begun to rot, thus accelerating the sinking process. The settlement map in the church area for the period

from 1963 to 1987 is shown in Fig. 4 as contour lines foundations of the tower and was mainly executed in 1993-94.

To stop the sinking of the church, the foundations were strengthened during the years 1993-96. The work began with strengthening. The last supporting structures and concreting work pouring for the tower were executed at the beginning of 1995 [3]. The other parts of the church foundations were strengthened in 1995-96. The foundations of the choir were not underpinned since they lie on hard soil and were not considered to be in immediate need of strengthening.

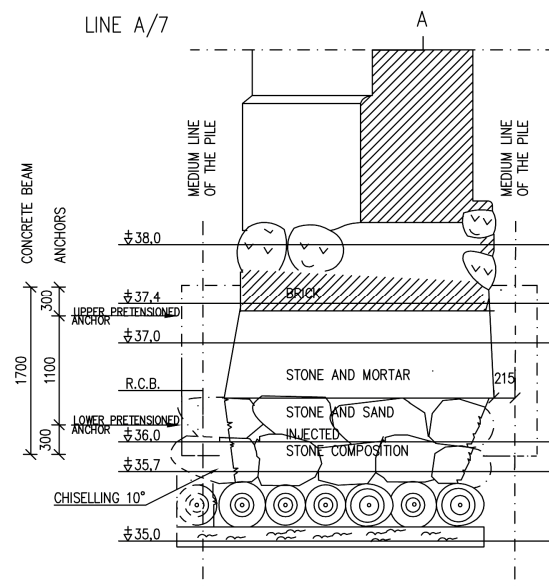
Figure 6. Section in the line A, the injected stone composition, lower and upper pretensioned anchors and beams. Chiseling was required prior to fabricating the concrete beams for them to carry the load to the piles from superstructure.

Underpinnings at lines A and B were made with drilled spiral piles. Because of the lack of a sufficient counterweight of the spiral piles in line B, the work was different from that of the line A. In the line A the walls were pre-injected with a water-cement-peipsisand mixture. In the first stage the pile locations were jetted and the piles were screwed as deep as possible because of adequate torque moment of the equipment. Reinforced concrete beams were cast on both sides of the wall above the piles, against an injected stone composition; see Fig. 6.

The concrete beams were forced against the old structure with prestressed anchorage. As the timber material of the plank foundations rots, all the

vertical loads will gradually be taken on by the piles. At line A, the piles also counteract lateral loads (F_{yk}) and moments (M_{yk}) from the rebuilt arch. The lateral load is $F_{yk} = 51 \text{ kN}$ and the moment $M_{yk} = 624.5 \text{ kNm}$. In line A, three piles of 340 kN allowable load each, and two piles of 360 kN outside the line work in combination. The lateral load of 10.2 kN for each pile is neglected in the design considerations.

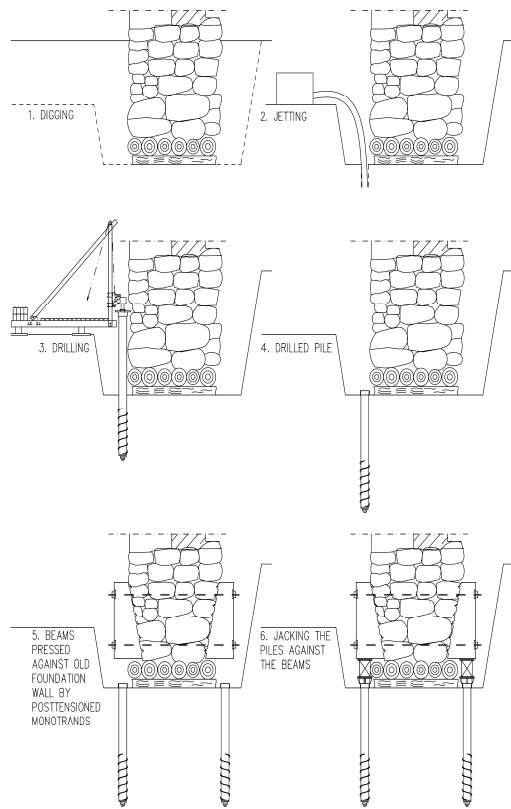
Figure 7. Working phases of drilled and jacked spiral piles.

The sequence of the work on the line A (part of the work could be done simultaneously)

1. Digging, first outside, then inside
2. Injection of wall 1 erection of pipes and shotcreting by hand; day 2: waiting for shotcreting to mature; day 3: injection of lower part; day 4 injection of upper part
3. Preparation of piles locations and cutting
4. Jetting of pile locations and installation of piles
5. Torquering the pile step by step
6. Boring of openings for anchors
7. Chiselling of the old stone foundation
8. Casting of concrete beams
9. Prestressing of the concrete beams together

10. Jacking the piles with special pretesting procedure in line A in incremental loading steps at 15 minutes intervals
11. End jacking procedure

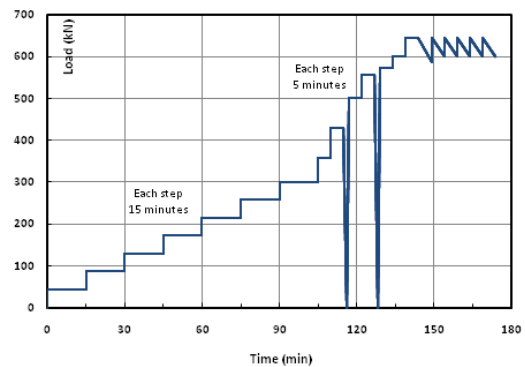
The pretesting procedure is illustrated in diagram in Fig. 8, which also includes the end jacking procedure. The pressure was held constant for 15 minutes at each step and the settlement was measured at 3 intervals (5, 10, and 15 min). When the pressure of 450 bar (644 kN) decreased in 5 minutes by less than 50 bar (72 kN) to 400 bar (572 kN), the end jacking could start.

Figure 8. Time intervals for test loading of each of the drilled spiral piles in the line A.

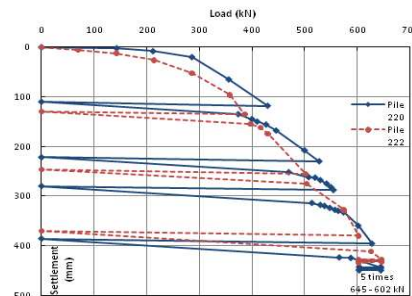
Figure 9. Load-settlement diagrams of drilled spiral piles Nos. 220 and 222 showing the repeated load cycling between 645-602 kN and end of pretesting procedure in the line A.

The soil layer, from dense to very dense silty sand, has about the same thickness (~ 4 m) but the upper level of the layer is slightly inclined. The area surrounding the church has in praxis the same geological strata. The outcome of the procedures with piles Nos. 220 and 222 indicate that using the same pretesting and end jacking procedure of the piles in line A, the allowable maximum load can be 400 kN. The safety factor gamma defined in DIN 1054 is 1.56.

Based on the load settlement diagrams of the tested drilled spiral piles the author noticed that without his pretesting and end jacking procedures the settlement in line A could have been approximately 25 mm. This can be noted from the settlement diagrams in Fig. 9. The surveying results from 21st October 1995 up to 9th June 2011 confirm that the pretesting and end jacking procedures worked well since there is no noticeable settlement in line A. It is therefore verifiable that the procedure is suitable for the dense to very dense silty sand layers of Tartu. One of the levelling points (No. 3) was noted to have risen, probably due the settlement in the strata of the tower. The maximum settlement during the period above mentioned is $5 \text{ mm} \pm 2 \text{ mm}$.

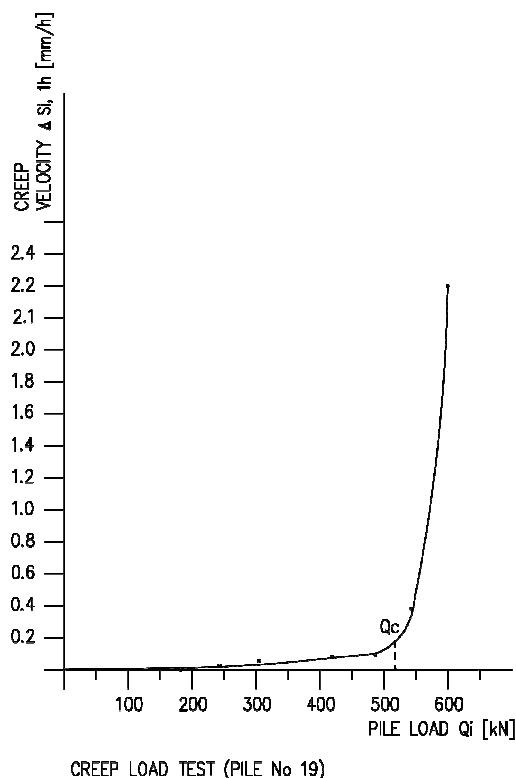
The allowable load above is less than the creep load $Q_c = 525 \text{ kN}$ (Fig. 10). The safety factor of creep is then

Figure 10. Creep velocity in the creep load Q_c is the load (pile no 19), which the curvature of the diagram corresponds to the minimum radius of the curvature in HGT.

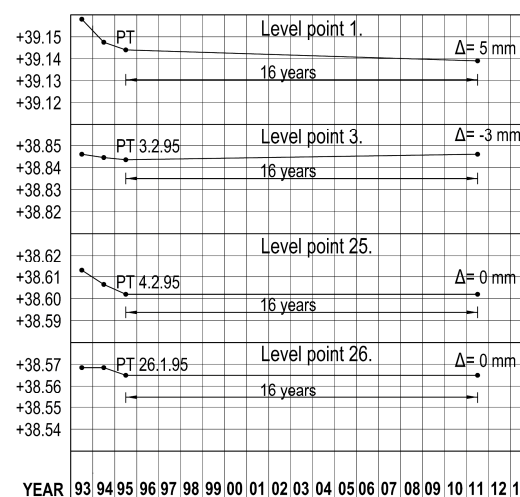
Figure 11. Data from line A: diagrams on 1993, 1994 and 1995. Pretesting and end jacking date (PT). Data added from the monitoring in 2011.
