# PRINCIPAL RENOVATIONS FOR THE OLYMPIC ROWING STADIUM IN HELSINKI, FINLAND 1996 – 1998 (Kari Avellan, KAREG Consulting Engineers)

Principal renovations for the Olympic Rowing Stadium in Helsinki were realized during the years 1996 to 1998. The consulting engineering firm KAREG was responsible for all structural renovation design: structural studies of corrosion effects, carbonation and hardness tests, strengthening and repairing plans of the structures. KAREG also supervised the work at site.

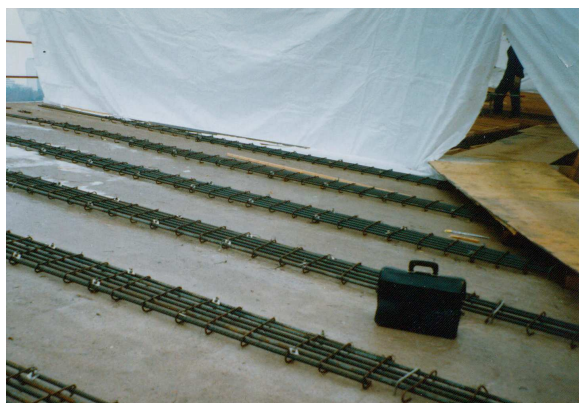
Photograph 2. Reinforcement ready for the upper parts of the beams and part of winter hall.

- 1-A temporary structure consisting of heavy timber shoring and bracing was built (Figure 2)
- 2- The Strengthening of the beams proceeded as follows:
  - (Photographs 2, 3 and 4)
  - Machine-grinding at a depth of 5 mm ( $3/16''$ ) of the surface of the roof slab, in an area 500 mm wide ( $1'-7 \frac{1}{2}''$ ) in line with the beams underneath that are 160 mm wide ( $6 \frac{1}{4}''$ ).
  - Cleaning and preparing the bonding surface
  - Reinforcement for the strengthening of the beams (Photograph 2)

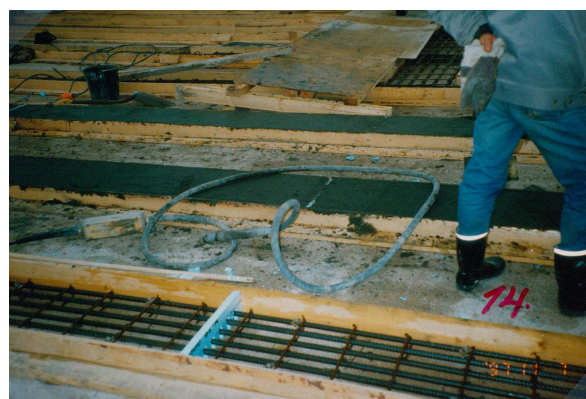
Photograph 4. Concrete pouring of the upper parts of the beams.

- Height of Formwork 100 mm (4") and width of 420 mm (1'-4 1/2") narrowing to 240 mm (9 1/2") at both ends (Photograph 3)
- Concrete pouring: The mix consisted of non-shrinking concrete EMACO S88 + 20% with natural gravel 5 to 10 mm (3/16" – 3/8") (Photograph 4)

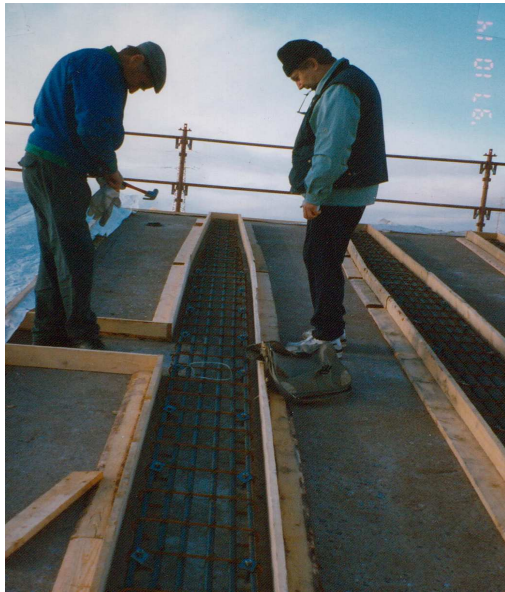
Photograph 3. Formwork and reinforcement of upper parts of beams. Mr. Kokko of the contractor firm Kokkoma Ltd and the writer.

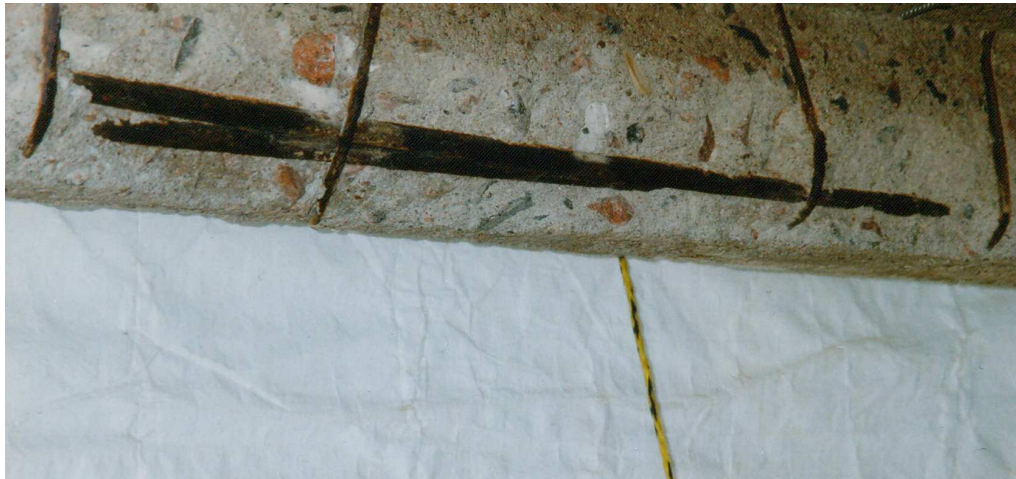
Photograph 5. Rand beam of the roof. Old bars visible.

After sandblasting and in some cases mechanical hammering, the reinforcement bars of the beams became visible. The bars were first treated with special rust control mortar and then with extra shotcrete (20 mm–30 mm [3/4"-1 1/8"]) to obtain a suitable surface for standard shotcrete and repairing plaster (Photograph 5).
