Blasting Near Old Foundations and Strengthening of Foundation Walls for the Headquarters of the Ministry for Foreign Affairs of Finland

SACH 2010 International Conference on Structural Analysis of Historical Constructions, 6th-8th October 2010, Shanghai, China

Kari Avellan KAREG Consulting Engineers, Töölöntorinkatu 11 B, FI-00260 Helsinki, Finland, kari.avellan@kareg.com

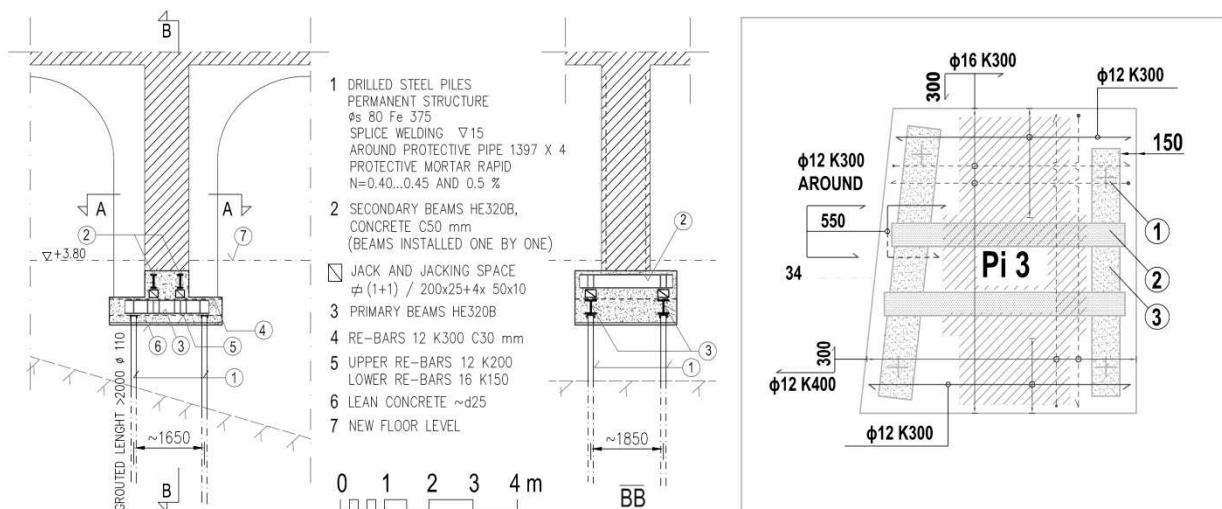
From the structural point of view, the building had three load bearing walls and two sectors: the northern wall on the sea side, the middle “kernwall” and the southern wall on the earth side. Because of the presence of surface rock beneath its eastern part, the three story building only had a basement in its western sector. Both sectors, east and west, were divided by a perpendicular heavy stone wall which had to be demolished during the underpinning work. For this reason, loads of the first floor were taken temporarily, partly by steel tension ties up to the old steel beams of the second floor, and partly on drilled steel piles (Fig. 2). The permanent support realised as a concrete arch similar to the existing ones nearby (Photograph 4), also acts to retain the earth pressures at rest. It was also taken into account during the construction stages that the weight of substructure would decrease temporarily because of the demolishing of old ceilings.

Figure 2: Perpendicular wall. Drilled steel piles. Steel beams and jacking system. Footing detail.

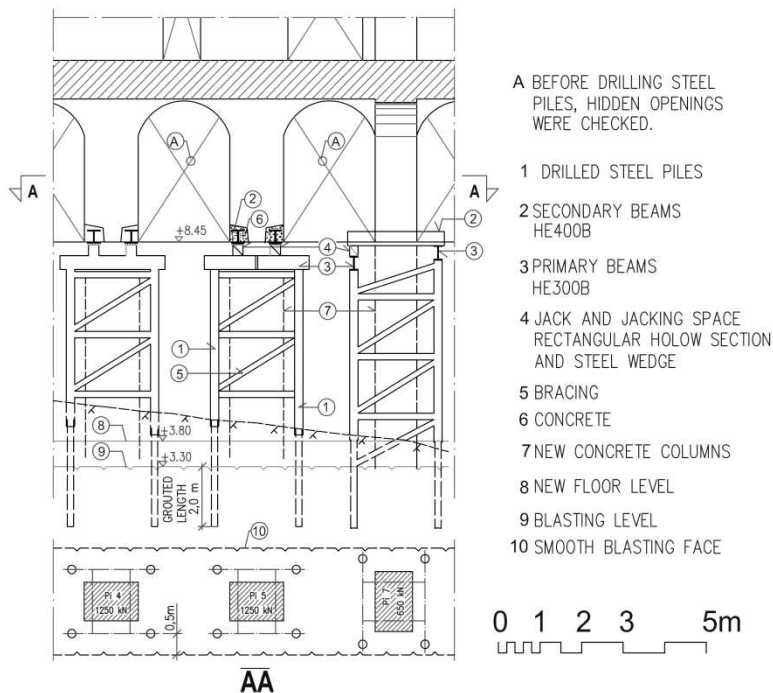
Once digging and rock blasting around and under the old brick columns was realised, new concrete ones were poured underneath them. The loads of the middle wall were initially taken on temporary structures and later transferred to the newly realised concrete column extensions. The sequence of work proceeded as follows: First, because of the presence of stratified rock and the blasting work, steel piles were drilled and cement grouted in the bedrock on both sides on the existing wall. Piles were designed separately as point bearing and as in-rock grouted piles. Steel beams were installed through the brick wall and loads taken by jacking the piles underneath them. The jacking operation itself was controlled by levelling in order to find the right jacking forces. During the digging work, the drilled steel piles were braced by welding rolled steel angles to them, effectively making them vertical trusses (Fig. 3).

Figure 3: Middle wall. Drilled steel piles. Steel beams and jacking system. Bracing.

Rock blasting with explosives proceeded around these trusses with a minimum safe distance from piles to smooth blasted face of 0.5 m. For work closer to the steel piles and underneath the brick columns / brick wall, only old hand methods such as loosening rock by using wedge and hammer in close spaced holes were normally accepted. In some cases the loosening of rock could be done by hydraulic wedge machine (Photograph 2). Formwork and reinforcement were realised inside the temporary steel structures and subsequently the new column extensions poured. In one sector of the middle wall, to establish a new floor level, foundations on moraine had to be realised. As mentioned previously, the loads were taken temporarily on steel piles. In this case the sides of the brick columns were prestressed by tension bars to prevent structural collapse during underpinning work. The steel piles were drilled with Odex equipment, with a casting tube of 139.7 x 5 and a core diameter of 80. Empty space between the tube and core was grouted using a cement mix w/c=0.45 and additives.

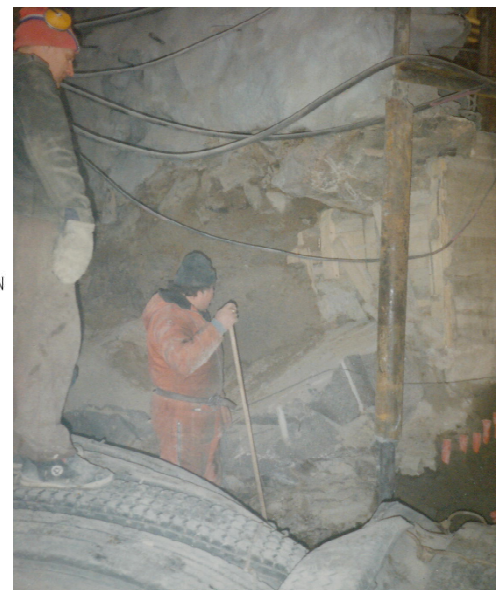
Photograph 2: Middle wall. Drilled steel piles. Smooth blasted face.

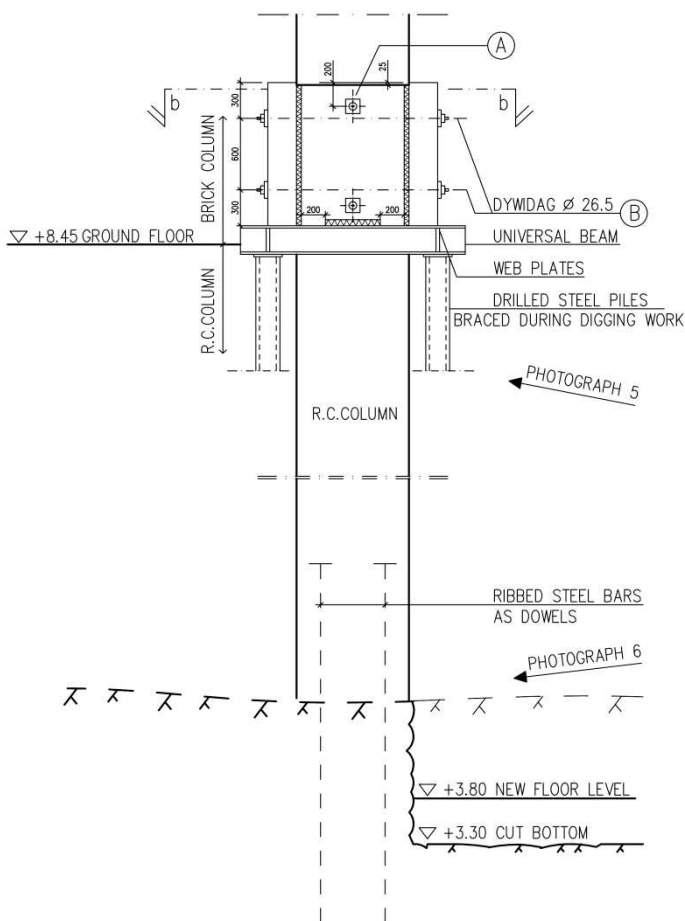
For both staircases, new concrete columns were poured underneath the existing brick ones, in accordance to the original dimensions. Furthermore, to avoid blasting damages, the entire column loads were taken by vertical steel dowels between concrete and rock (Fig. 5). The blasting and loosening of rock was made as mentioned previously for the middle wall.

Figure 5: Eastern stair column. Pretensioned concrete mantel. Vertical steel dowels.

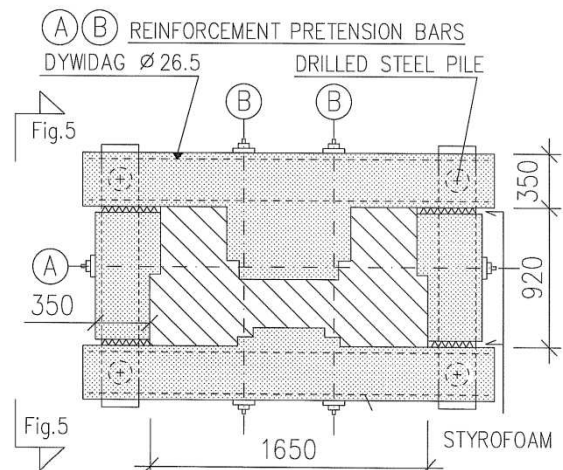
As in the case of the middle wall, the loads from the brick-made staircase columns were temporarily supported by drilled steel piles. Each irregularly shaped brick column needed first to be covered in a concrete mantel. Subsequently, in order to get enough friction force between the concrete and the column, the mantel was stressed against it by tension bars. To be sure that pretension on the concrete plate was properly set against the column the mantel was divided into four sections with Styrofoam joints in between them (Fig. 4, Photograph 3). Similar structural “independent” pre-stressed panel technique was also used later on (Avellan and Maanas 2001).

Figure 4: Eastern stair column. Pretensioned concrete mantel. Drilled steel piles.

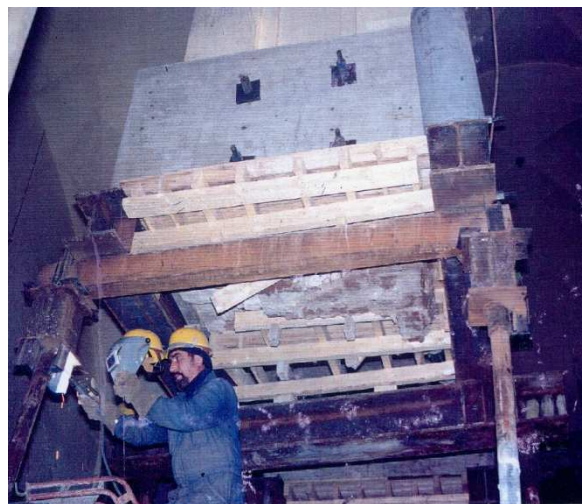
Photograph 3: Eastern stair column. Old brick column. Pretensioned concrete plates. Temporary steel supports.

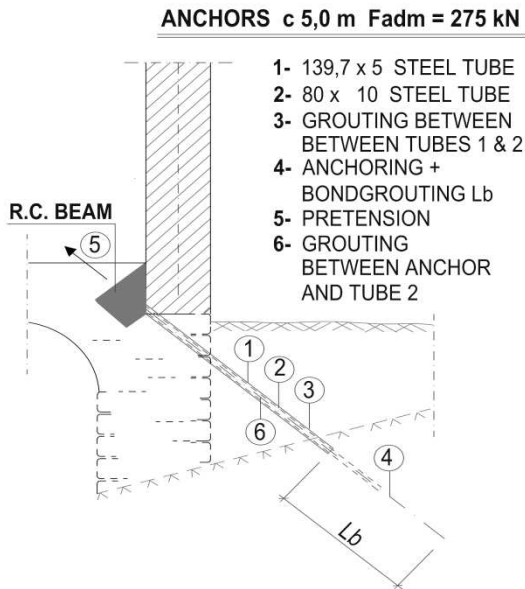
Near the southern wall, a pipe channel was built to the level + 2.5 m. The old wall was not strong enough to retain the earth pressure at rest. To solve this problem some of the earth adjacent to the wall was substituted with Leca-aggregate, hence the pressure minimized. Additionally, the wall was supported by using pre-stressed permanent rock and earth anchors (Fig. 6). These anchors were designed to take compressive as well as tensile forces.

Figure 6: South wall. Rock and earth anchors. Photograph 4: Reinforcement of concrete arch.

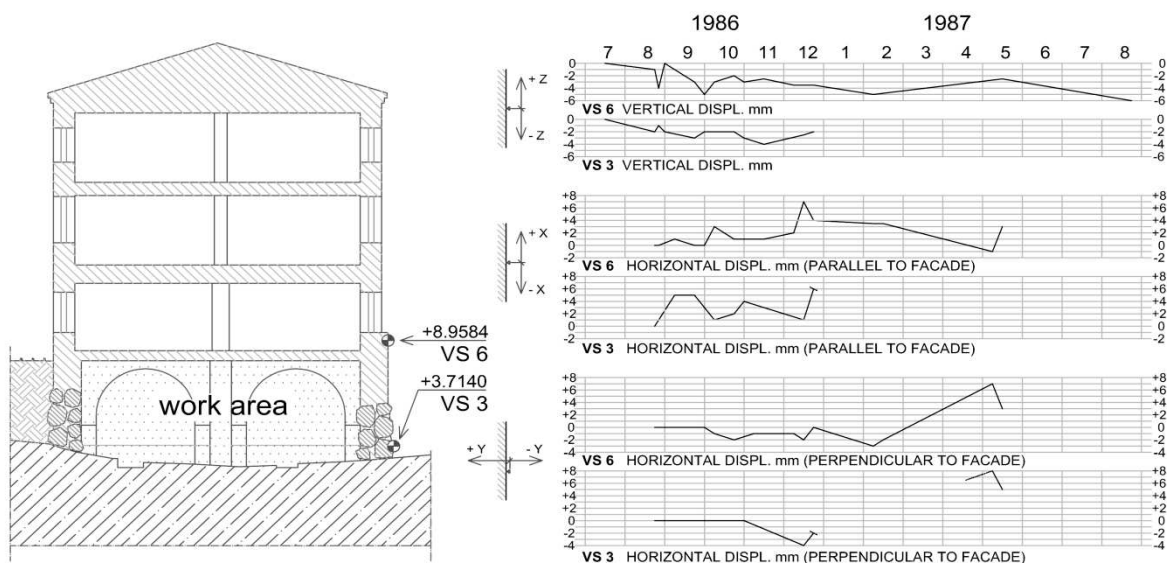
Figure 7: Measurements of facade movements during work (2 points at one of three exterior sectors).

Throughout the work, horizontal displacements of the middle wall were small because the loads were taken temporarily by steel piles, which were grouted in rock and the loads of beams jacked against deflection. Possible dangerous situations were avoided by monitoring points at regular intervals, during the whole period of work (Fig. 7). A very slight inclination of the southern wall towards the sea was registered and the displacements measured locally at 2 mm (at level +3.99) and 4 mm (level +8.5). The reason for this displacement was thought to be a strike from the “Bobcat”, or the result of blasting or both. As a precautionary measure more bracing was done.
