Lectio praecursoria 12.11.2011: Kari Avellan Limit state design for strengthening foundations of historic buildings using pretested drilled spiral piles wirh special reference to St. John's Church in Tartu

St. John's Church, Tartu Estonia

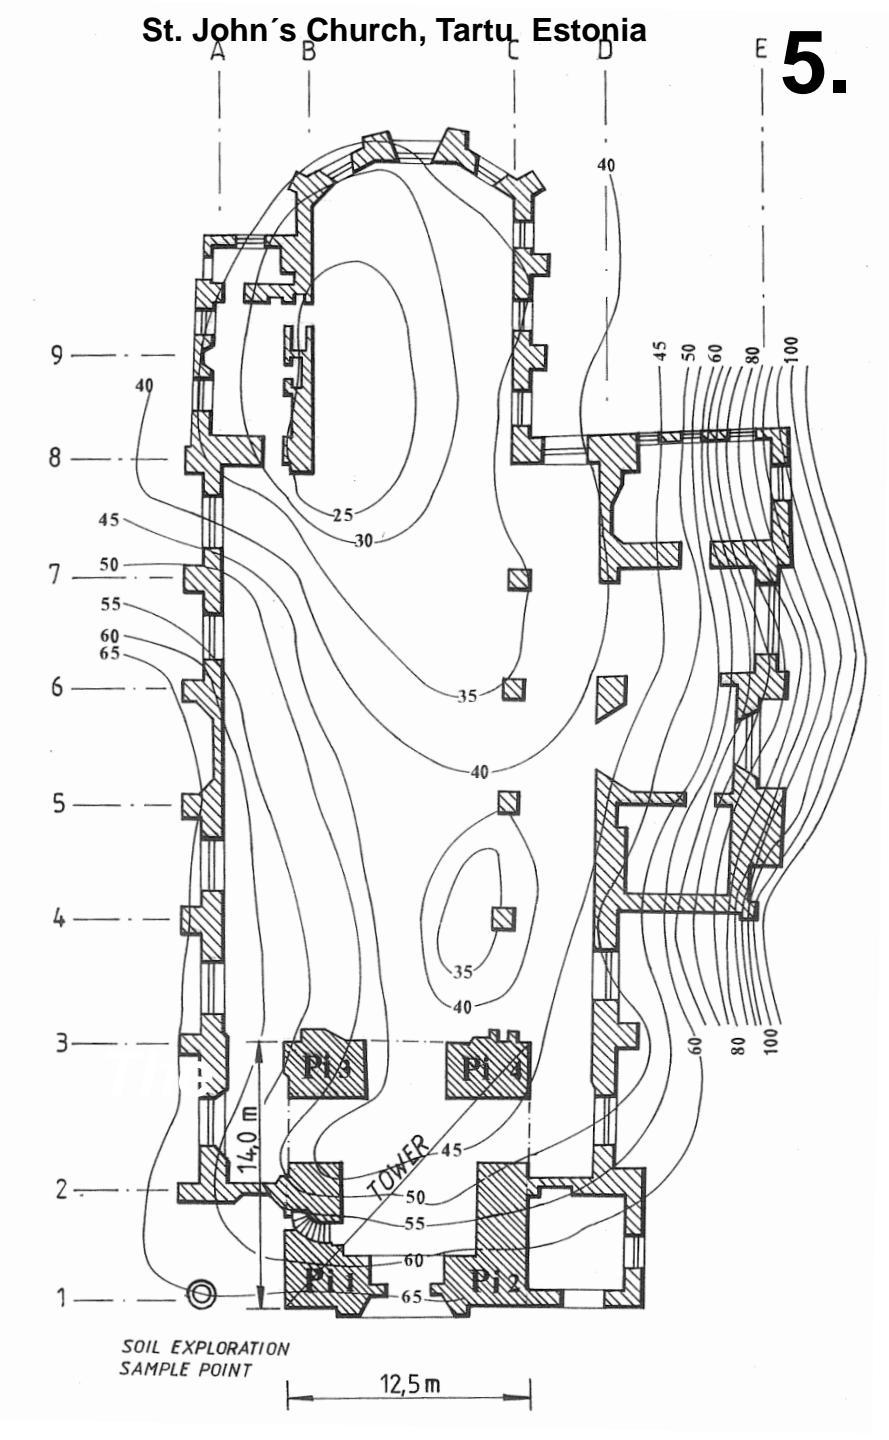
Church before the strengthening work, line A is on the right-side with-out roof, columns on line B had to be entirely rebuilt. St. John's Church, Tartu Estonia

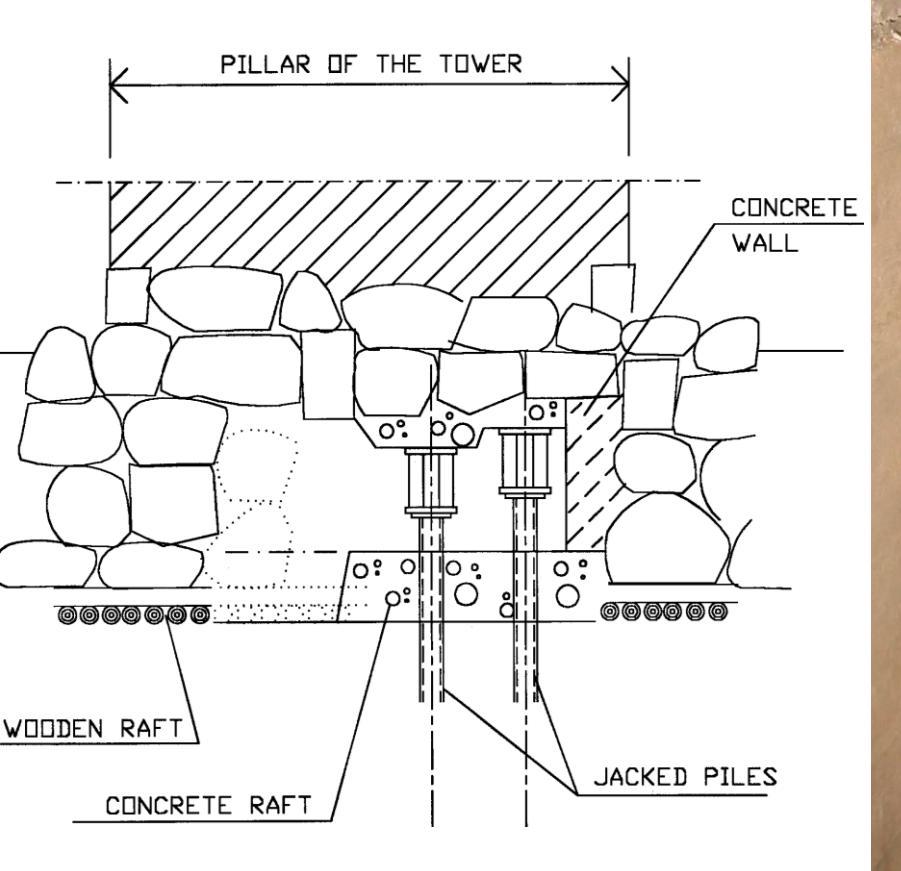
• The tower lies on four pillars which rest on wooden rafts. The foundations of pillars were strengthened by method of underpinning using jacked steel tube piles. Piling of pillars was done gradually, demolishing partly stone composition and piling the demolished part at the same time. Reinforced concrete raft foundation d = 600 mm thick was cast part by part with piling work.

The purpose of the empty space is to give archaeologist and engineers chance to study the place in situ in future. The figure on left shows the previous and present situation of the tower foundation.
