Kari AVELLAN, D.Sc., C Eng., P.E.

REFERENCE PROJECTS IN THE AREA OF EXPERTISE

Structural and geotechnical engineering for special projects

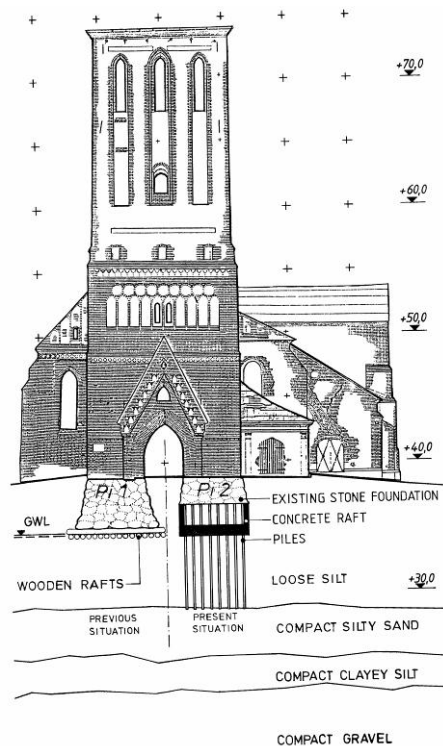
Picture 1. St.-John's Church
Foundation of the tower. Previous and present situation.

- built between 1300 - 1460
- 1.1 Underpinning of the tower between 1993 - 1994 (**pictures 1 and 2**)
- 1.2 Underpinning of the church between 1994 - 1996
- structural and geotechnical design and technical management of the project, jacked piles, spiral drilled piles, permanent pre-tensioned anchors
- investigation/inspection of the condition of the structure on the site
- teaching/training for local unskilled workmen to get skills and competence to execute the work.

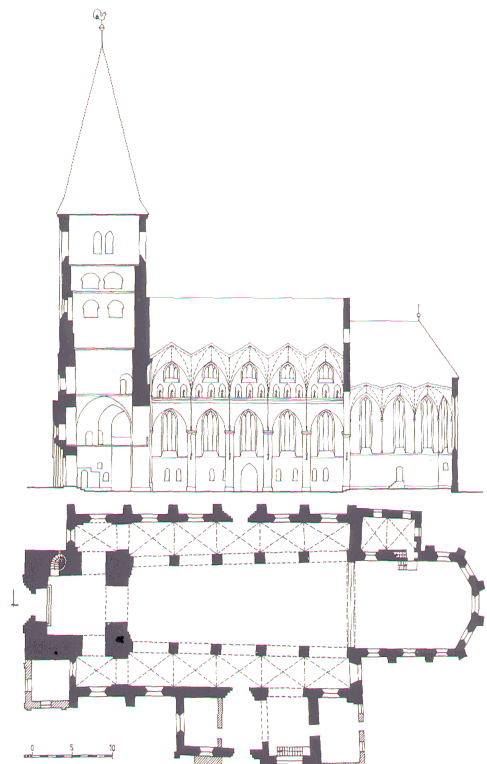
Picture 2. St.-John's Church
Plan and section of the church.

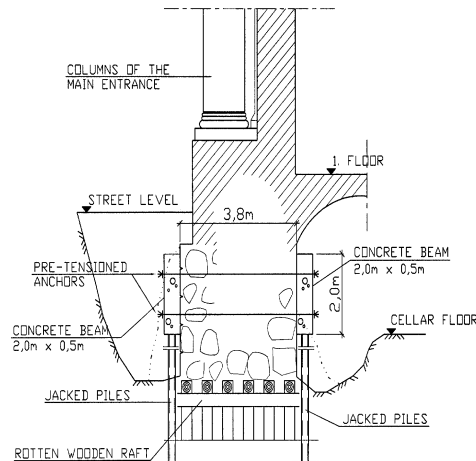
Picture 3. The Main Building of Tartu University
Section of the main entrance.

- built between 1802 - 1806
- strengthening the foundations and specially the foundation of the main entrance (**picture 3**)
- structural and geotechnical design and technical management of the project with the main focus on the foundations and the concrete structures from cellar to ground floor (middle and south parts of the building)
- investigation/inspection of the conditions of the structure on the building site
- teaching/training for local unskilled workmen to get skills and competence to execute the work.

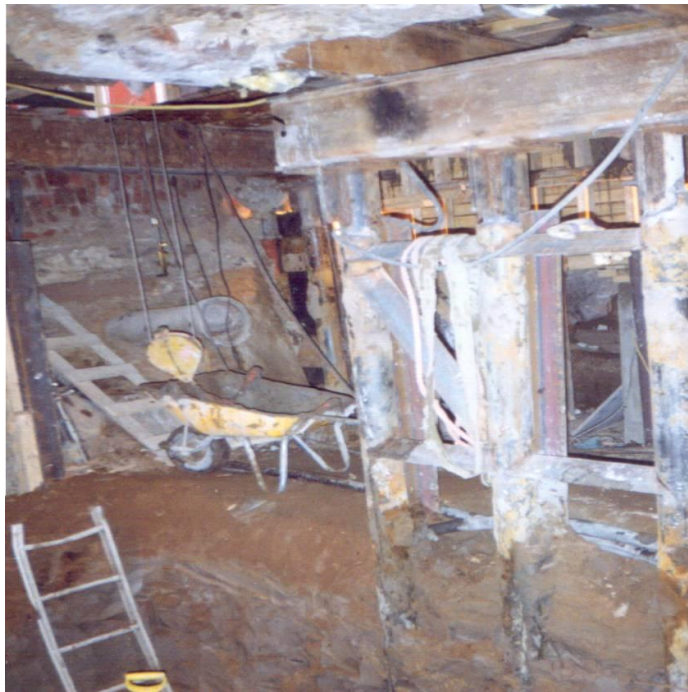
Picture 6. Digging work under old structures of Aleksanterinkatu 4 - 10.

- shoring of the walls during reconstruction
- underpinning operations, rock blasting and recess of the cellar
- design of temporary and permanent structures (steel and pre-stressed concrete structures)
- geotechnical and structural design of the foundations and the concrete structures from cellar to ground floor (**picture 6**).

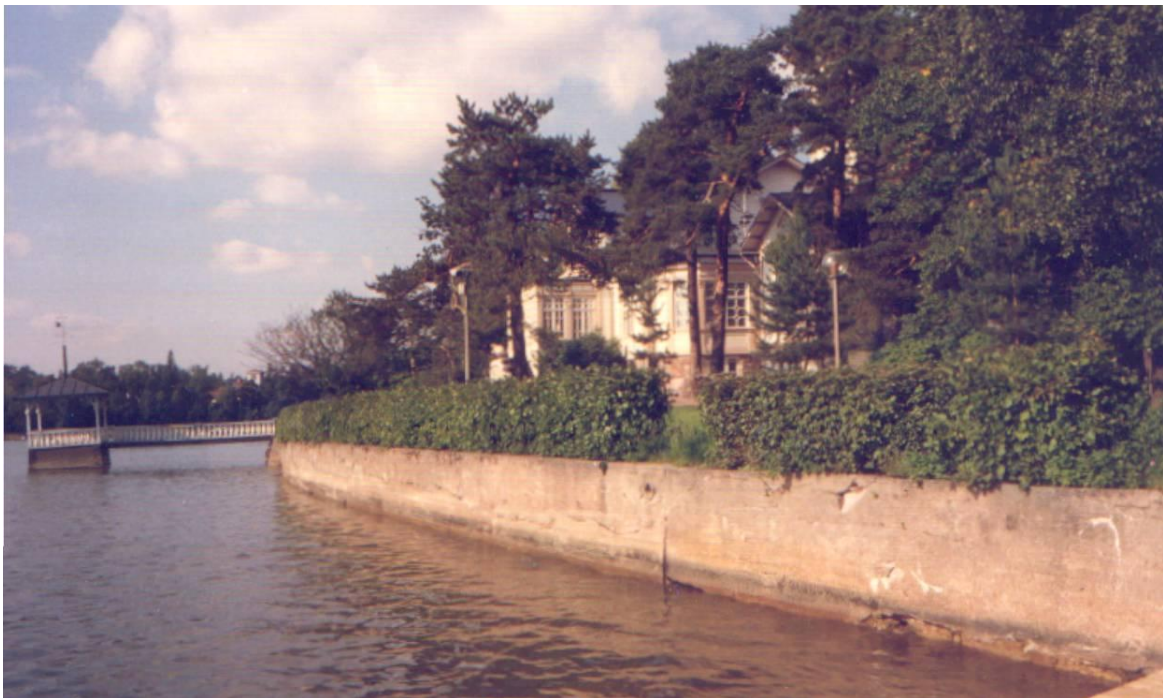
Picture 7. The Prime Minister's official residence.

- diving inspections as well as improvement and renovation plans for the residence of Prime Minister of Finland (**picture 7**).
