KARI AVELLANIN KIRJOITUS JA POSTER
Reawakening the spirit: St. John's Church of Tartu, Estonia
ICOMOS 16th GENERAL ASSEMBLY SEPTEMBER 29th TO OCTOBER 4th 2008
ISCARSAH MEETING SEPTEMBER 29th
QUEBEC, KANADA

*Kari Avellan, KAREG Consulting Engineers, Finland &
Kalle Lange, Muinsuskaitseamet, Estonia*

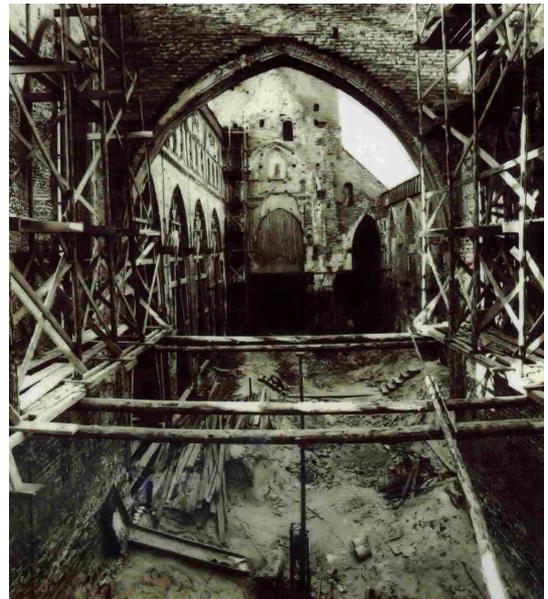
Picture 1. State of Church before restoration.

The story of the church in the post-medieval period is a history of multiple destruction and rebuilding, loosing many of the original features through the process. During World War II, in 1944, the church burned down and remained in ruins for the whole period of Soviet occupation (Picture 1).

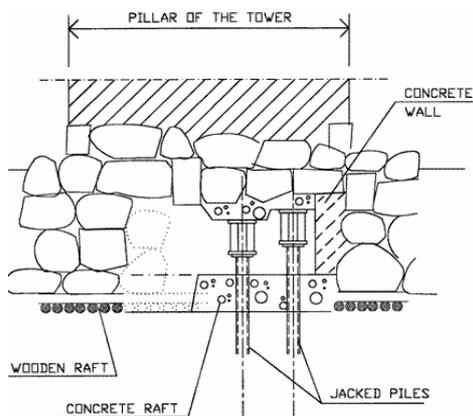
Figure 3. Monolithic floating pile raft foundation.

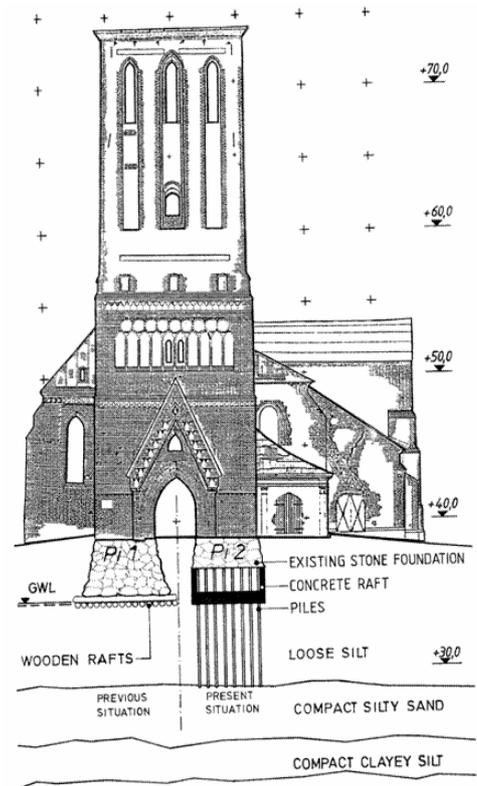
Figure 2. Underpinning of Tower.

A simple and practical technique was devised to screw the spiral drilled piles in a very confined working space. Steel tube piles were jacked down under the existing structure, using it as a counterweight. Spiral drilled piles were used in those walls without a counterweight condition. The underpinning of the tower proceeded step by step while concrete was poured to make a monolithic floating pile raft foundation (Figure 3). Reinforced beams were also constructed on both sides of the wall foundations, and pressed with post-tensioned anchorage against the structure. A field load test was performed on all piles and the rate of settlement measured. Between the old stone and new concrete structure, a viewing space was kept to give archaeologists and engineers the opportunity to study the foundation "in situ" in the future (Picture 2).

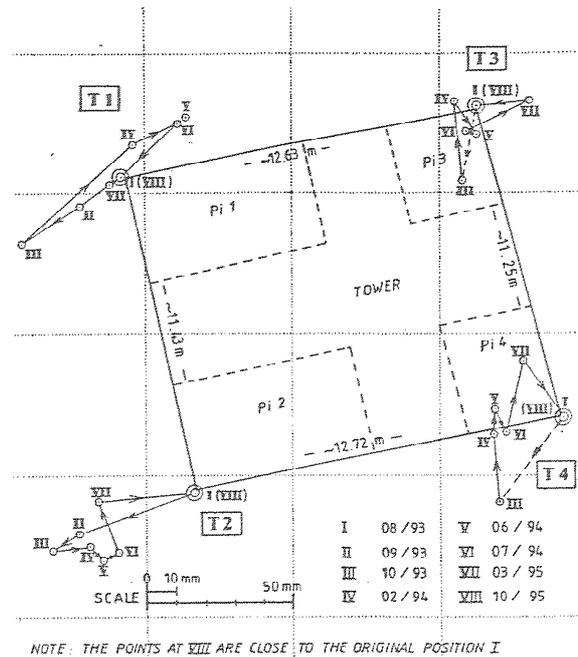
Figure 4. Horizontal displacements of Tower.

The rate of settlement and horizontal displacements, particularly of the tower, were measured throughout the process. Due to the construction technique, the overall settlement of the tower was only 18 to 20 mm. The horizontal displacement was registered at a maximum of 50 mm during work, and measured at 20 mm after the work completion (Figure 4).

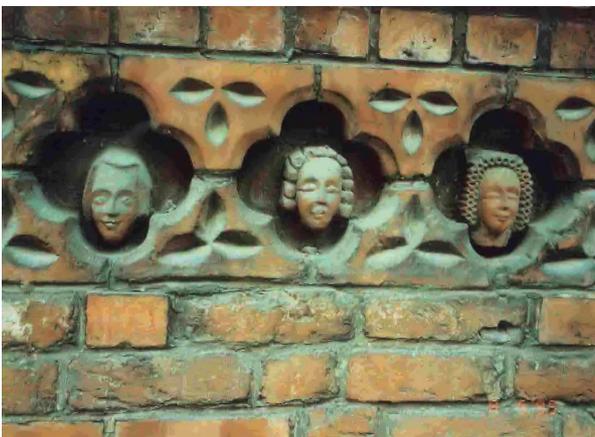
Picture 3. Terracotta figures.

Today the church works as a polyfunctional building: the primary function is a working church, the other functions linked to the main use are being a cultural monument open for the public with exhibited terracotta originals (Picture 3) and being a concert hall as well. The association of St. John's Church and the University congregation combined the ecclesiastical spirit with the academic spirit of Tartu University, founded in 1632.
