Strengthening the foundations of the main building of Tartu University, Estonia

K. AVELLAN

KAREG Consulting Engineers, Helsinki, Finland

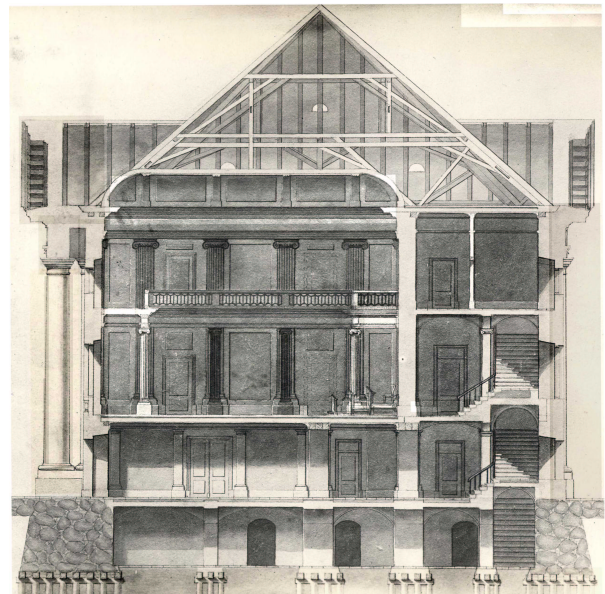
Figure 1. Historical section of the building.

Massive stones are set over two to three layers of timber rafts, which are supported on timber piles. The timber rafts stay at the level of about five meters below the street level. The basic soil is soft freshwater marl. The thickness of the marl layer varies from 3 to 5 m and the deformation modulus is about 2 MPa. Marl is laying on very dense layer of gravelly soil. The structures and the Dorian columns upon the foundation of the entrance wall are shown on the left side in the historical section of the building (Figure 1).

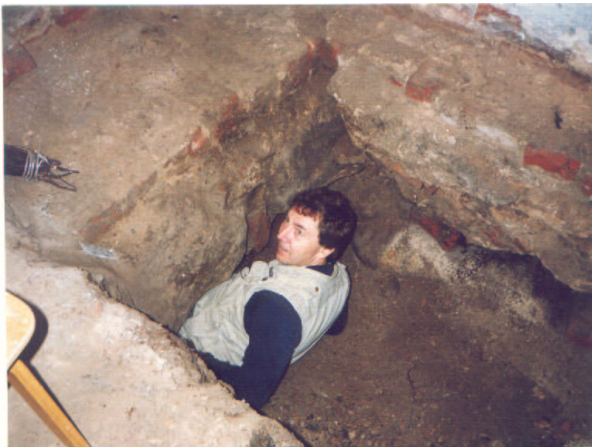
Photograph 1. In situ proof under foundation.

In early 1990's it was noticed that the situation under the center part of the building started to be critical. In pre-work archeological diggings the wooden rafts were in some places totally rotten leaving empty cavities at a place they used to be. To proof the situation of cavities, the main author of this paper was asked to be in situ under the foundation (Photograph 1). Especially the area of the main entrance needed immediate repair to prevent any serious damage of the building (Photograph 2).

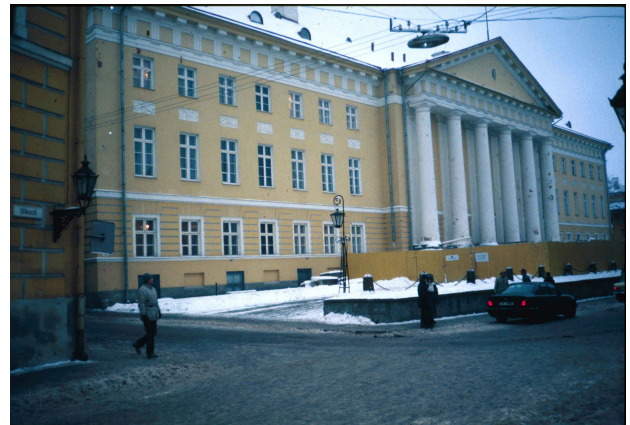
Photograph 2. The University building during the work in 1995.

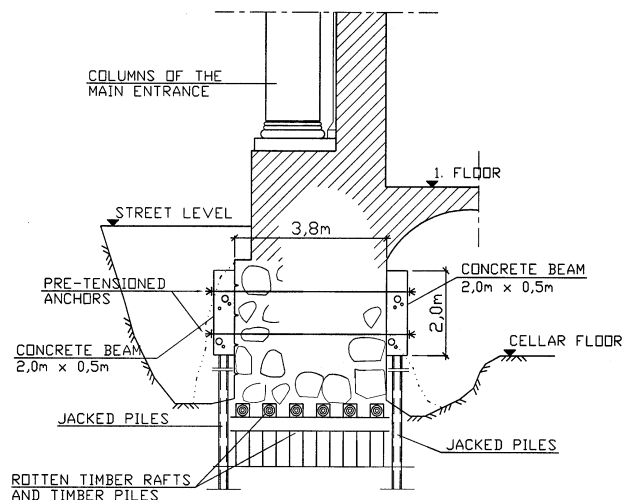
Figure 2. The principal of the work under the main entrance wall of the building.

The strengthening work in the area of the main entrance started by casting concrete beams $h \times b = 2.0 \times 0.5 \text{ m}^2$, both sides against the original stone and brick masonry of the cellar wall (Figure 2 and Photograph 3).

The stone and brick masonry wall of the main entrance was injected. Then reinforced concrete beams were cast and post-tensioned against the old structure.

Each post-tensioned anchorage consists of 7 plastic-sheathed greased strands (monostrand) SUP 1630/1860, $A_s = 140 \text{ mm}^2$.

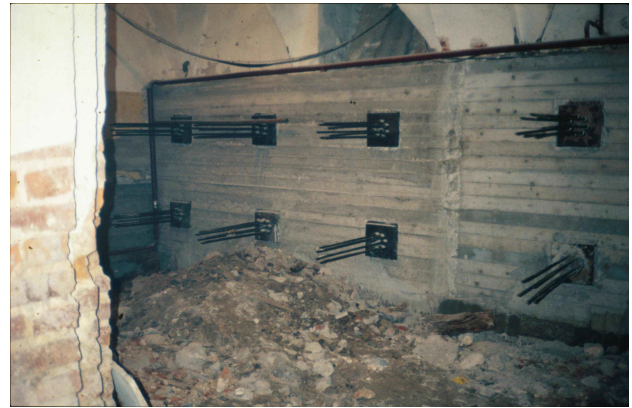
Photograph 3. Concrete beam $h \times b = 2,0 \times 0,5$ m² against the old cellar wall and pre-tensioned anchors.
