PROCEEDINGS OF THE INTERNATIONAL SYMPOSIUM ON GEOTECHNICAL
ENGINEERING FOR THE PRESERVATION OF MONUMENTS AND HISTORIC SITES
NAPOLI/ITALY/3-4 OCTOBER 1996

St-John's Church, Tartu, Estonia – Underpinning of tower

K. Avellan
KAREG Consulting Engineers, Helsinki, Finland

K. Lange
AS Stinger, Tartu, Estonia

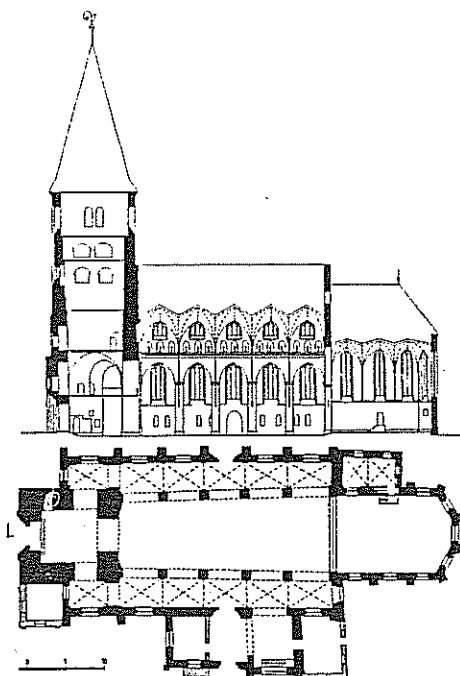
Fig. 1. Plan and section of the church.

The first data about the church or a congregation dedicated to St. John comes from 1323. The wooden rafts supporting the foundations of the church probably date from the end of the 13th century. The mentioned rafts are below the tower; the choir and the so called Lübeck Chapel on the southern side of the church are built without

supporting rafts. Other parts of the church also rest on wooden rafts.

The stone church was erected over a burial ground. In the first stage the choir of the church was built on a foundation of sand and granite stones. Initially the choir possessed a straight apse, which during subsequent rebuildings has become an octagonal one. During the next stage the central nave and the tower were added. As the Downtown of Tartu is situated on a relatively soft ground, stability of the building was achieved by placing wooden rafts beyond the foundation stones. There are two layers of logs in the rafts. The rafts have survived partially, but due to the instable ground the church foundations need underpinning as the building has settled unevenly.
