ECSMGE XV European Conference on Soil Mechanics & Geotechnical Engineering, 12.. – 15. September 2011, Athens, Greece

Drilled spiral piles in St. John's Church of Tartu, Estonia

K. Avellan

KAREG Consulting Engineers Ltd, Helsinki, Finland

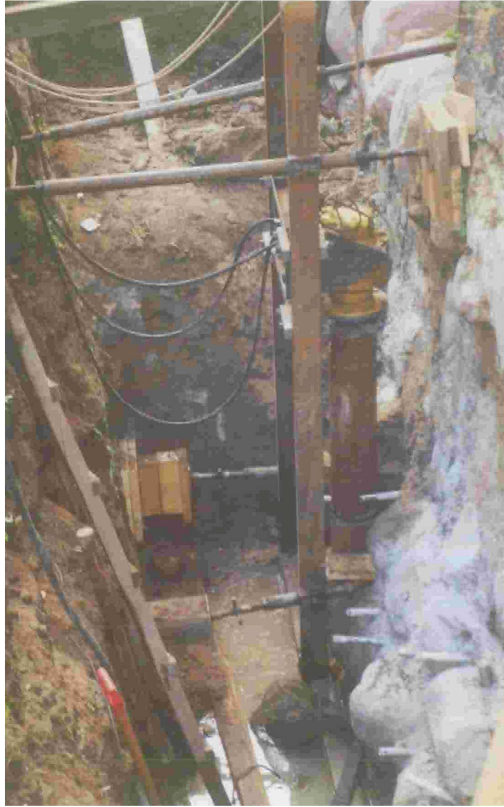
The piles were embedded in the soil by twirling. The joints of the spiral drilled piles were made by welding the parts together and jacking them. The completed piles were filled with concrete. The total length of the piles on axis A varied from 5.5 m to 6.5 m. A practical and simple technique and equipment was devised to enable the assembly of the spiral drilled piles by screwing in very limited workspaces. All the parts of the necessary equipment could be equipment could be carried by workmen Fig 5.

Figure 5. Simple screw driving equipment for drilled spiral piles.
