Lectio praecursoria 12.11.2011: Kari Avellan Limit state design for strengthening foundations of historic buildings using pretested drilled spiral piles wirh special reference to St. John's Church in Tartu

St. John's Church, Tartu Estonia

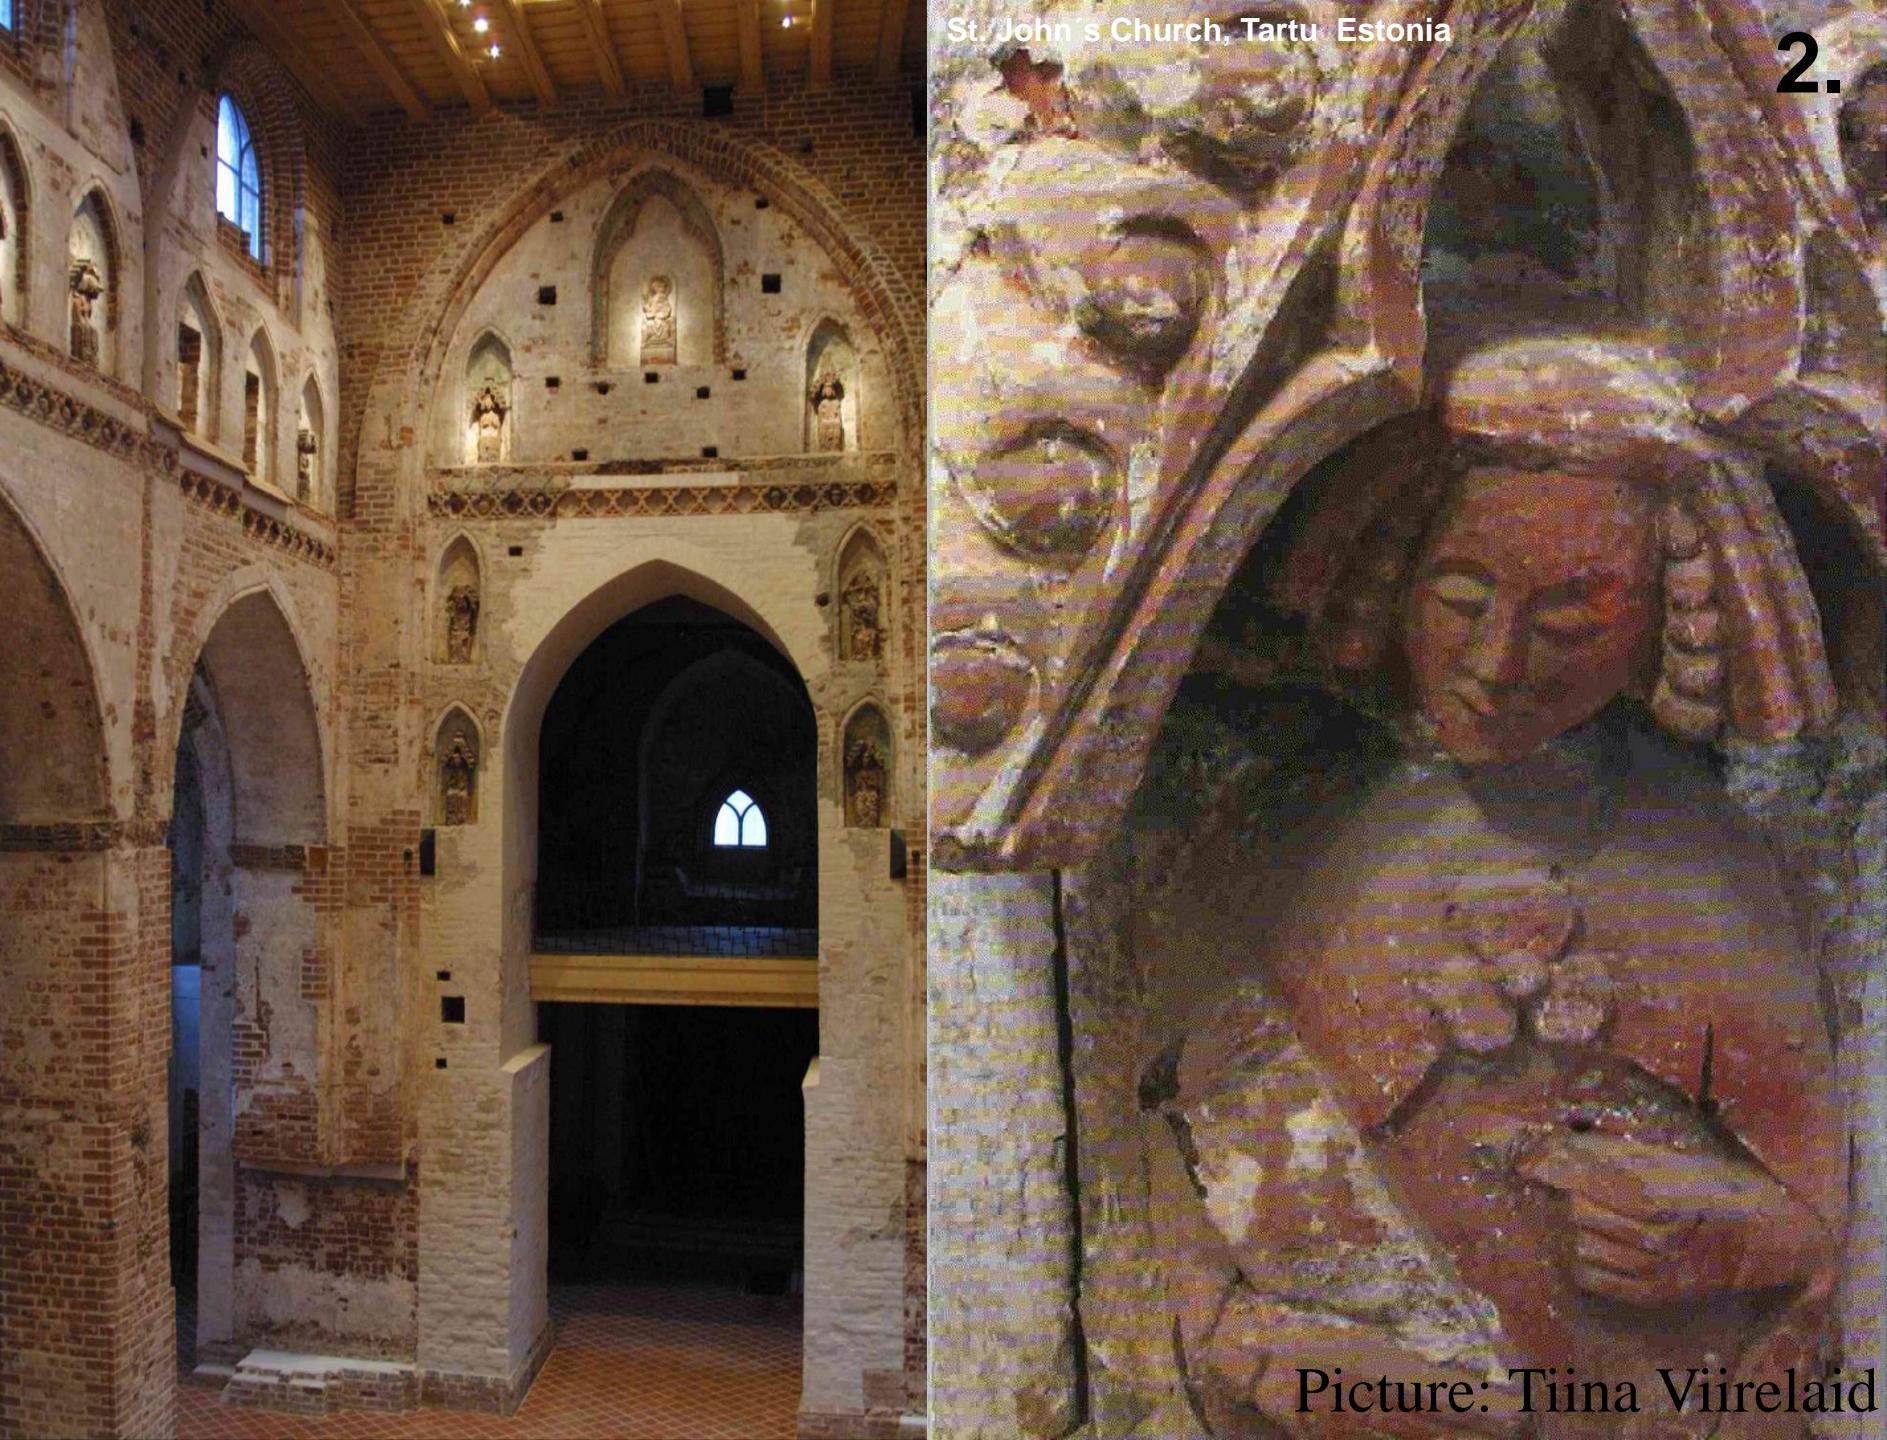
Church before the strengthening work, line A is on the right-side with-out roof, columns on line B had to be entirely rebuilt. St. John's Church, Tartu Estonia

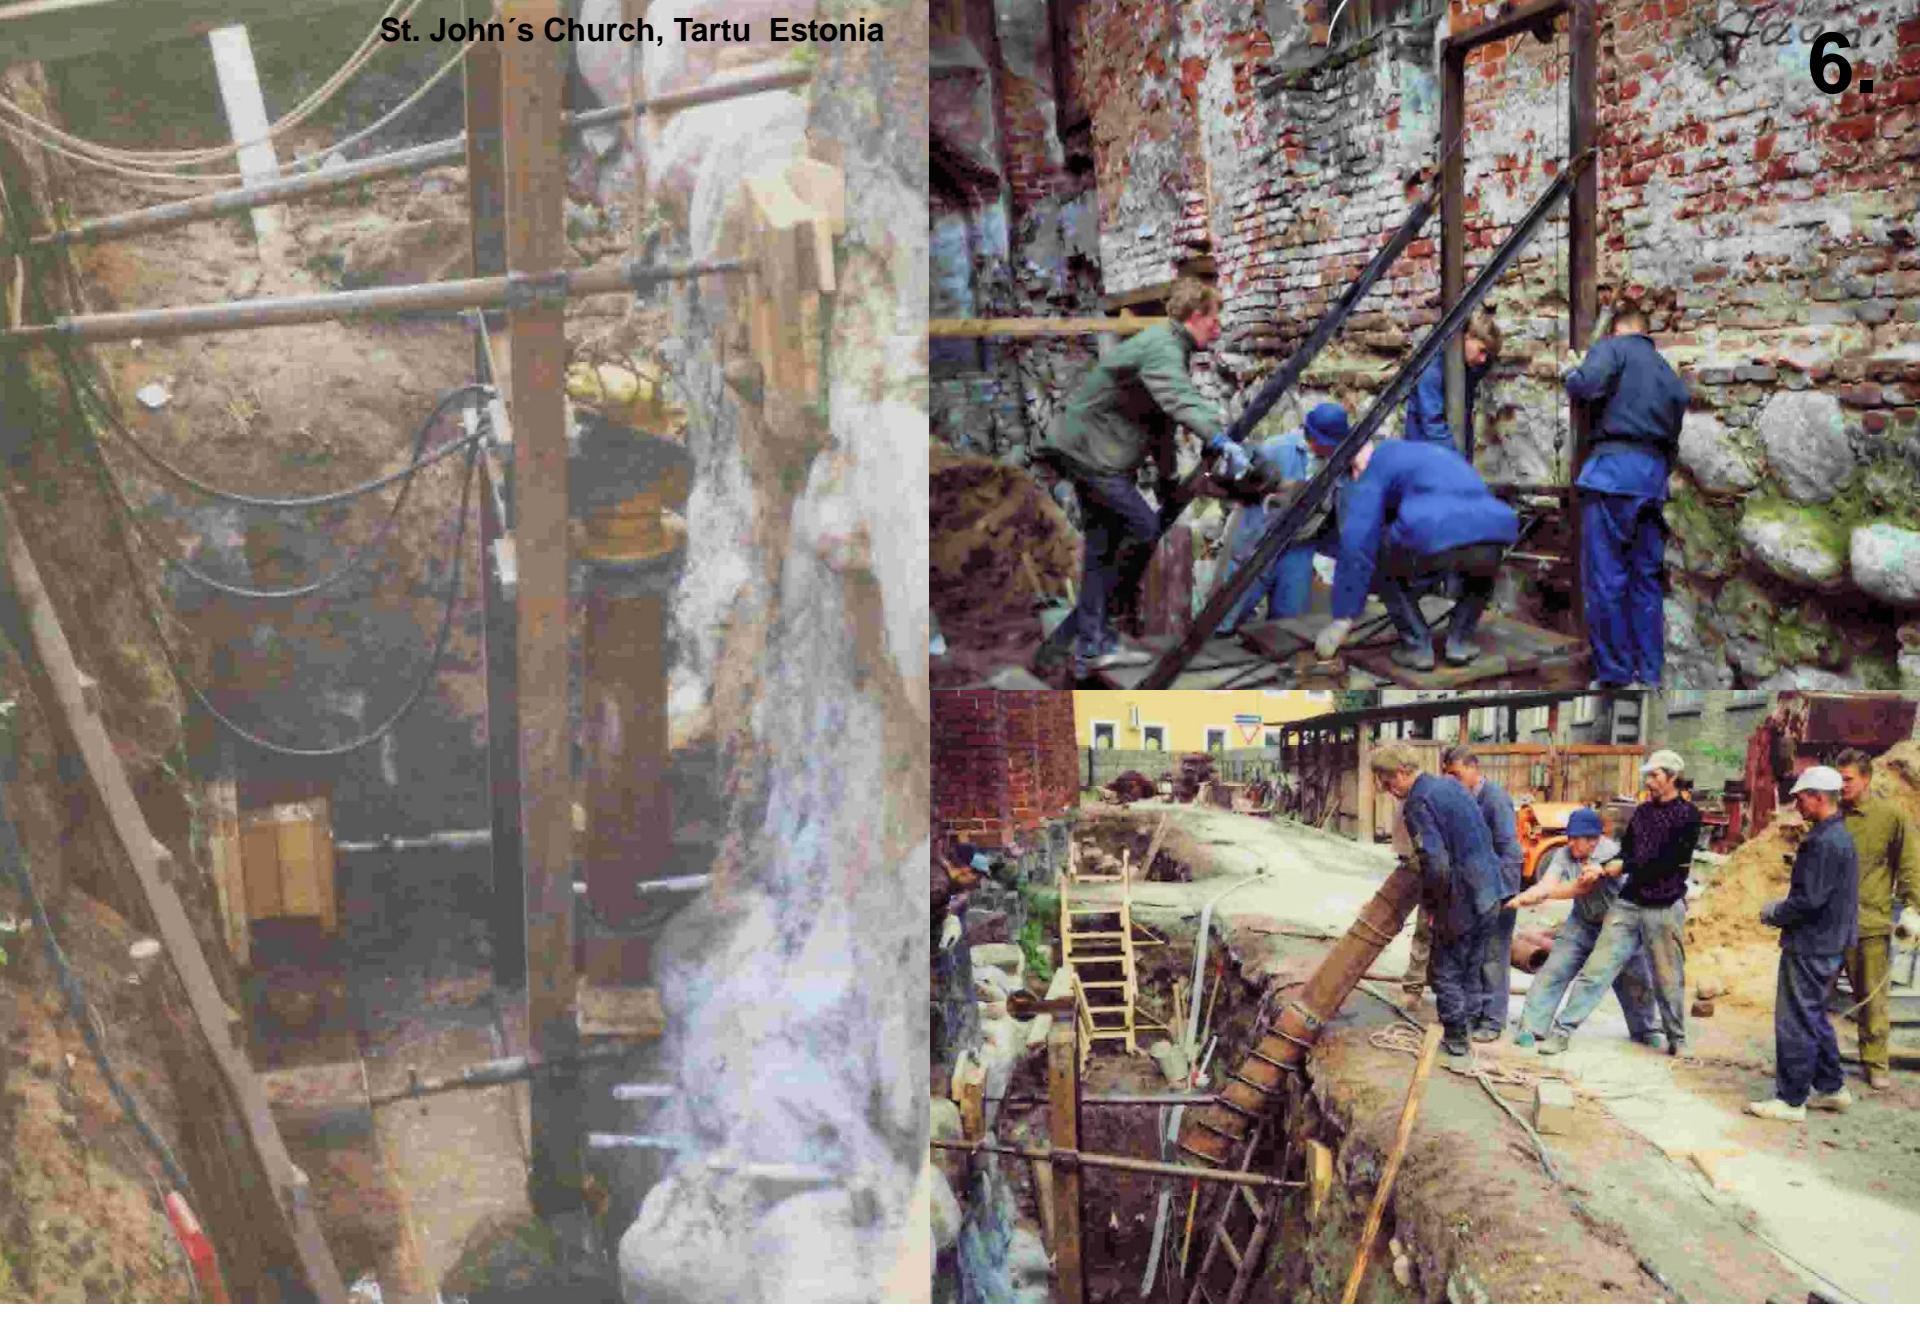
Simple screw driving equipment for drilled spiral piles. KAREG also trained local workmen.
